MISCELLANEOUS PAPER GL-89-19

CONDITION SURVEY REPORT ROBINS AIR FORCE BASE, GEORGIA

September 1989

Final Report

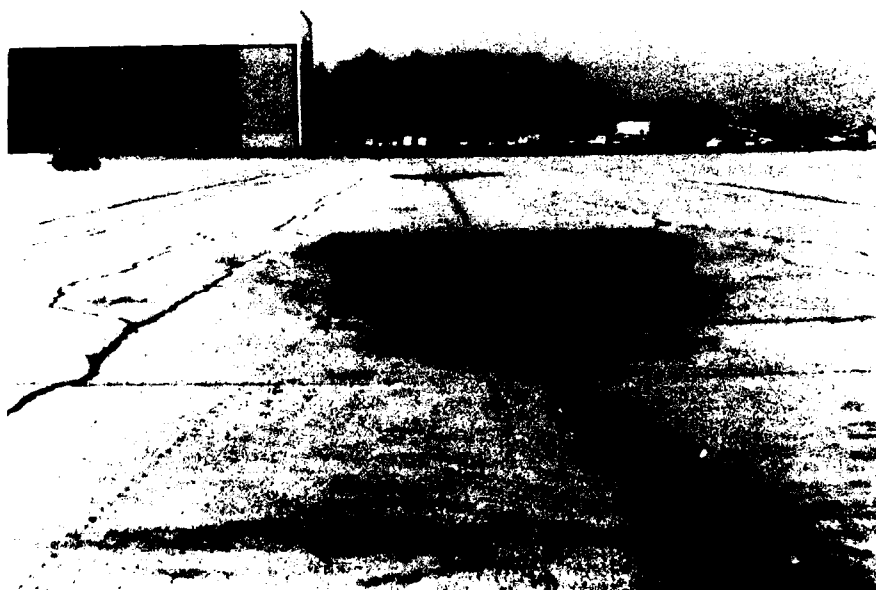
Photo 20. Depression and cracking associated with drainage structure subsidence, northwest apron (A5B)

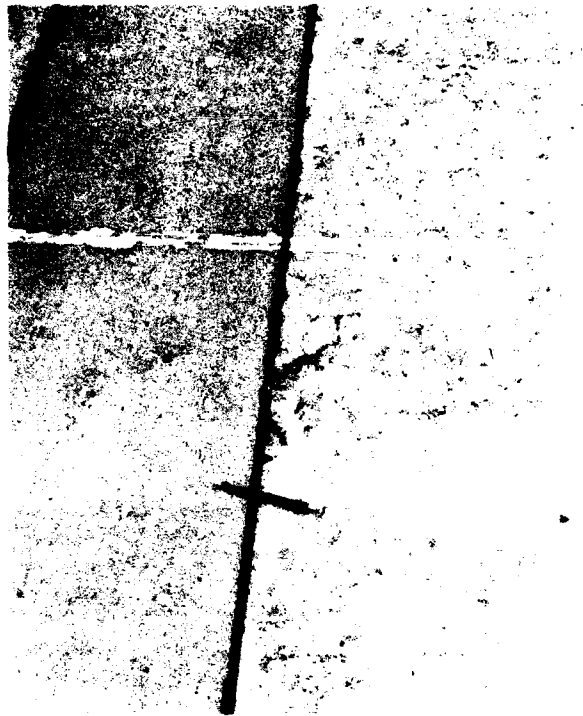
Photo 25. High severity spall adjacent to
low-severity patch, dangerous cargo pad
(A16B)
